# TOP ANTENNA WASHOUT?

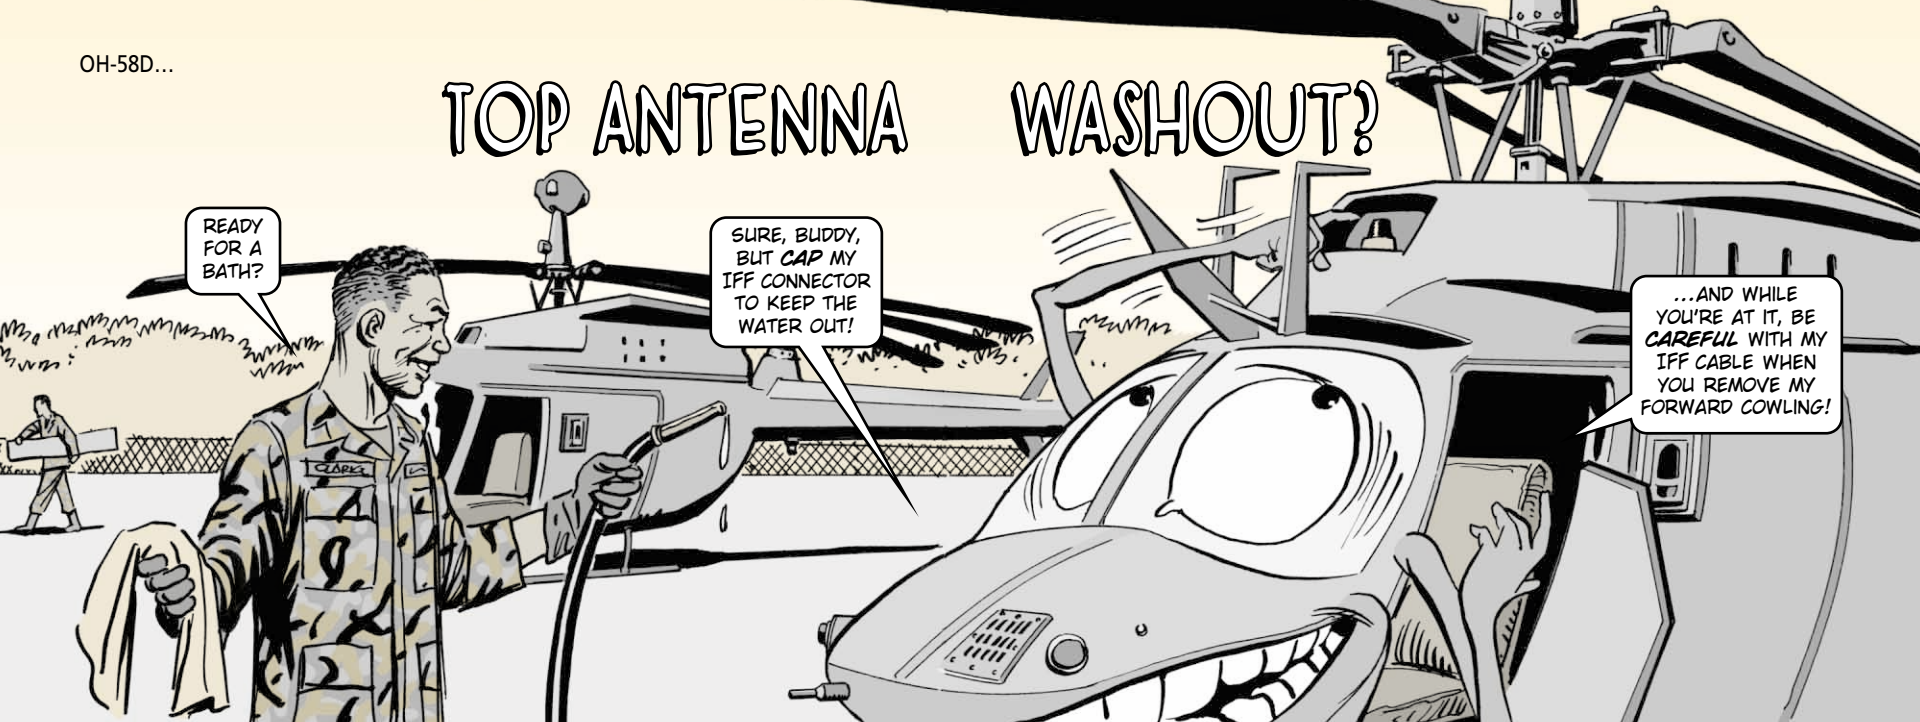
Anytime you wash your Kiowa Warrior with the forward cowling removed, remember to cover the top IFF antenna receptacle. If you forget, water gets in and can short out the antenna when you reinstall it.

That means you'll get a NO-GO reading on the MFD (multi-functional display) when you do your pre-flight checks. A NO-GO means your aircraft isn't ready to identify itself to other aircraft and ground facilities.

'Course, a NO-GO could also flash if you're too rough removing the cowling while the cable is still attached. Any pulling or tugging can damage the IFF cable. So check the cable and the connector pin for damage if you get a NO-GO.

If you get the NO-GO readout only after you've washed the bird, put a small amount of isopropyl alcohol, NSN 6810-00-286-5435, in the antenna receptacle. That will dry up the excess water. Or use a blast of shop air to blow out the water.

Once it's dried out, do another operational check on the top IFF antenna to make sure it's working. If it still won't work, troubleshoot the IFF antenna system.

Keep that NO-GO at bay by taping the receptacle or putting a plastic cap, NSN 5340-00-211-8188, on it before you wash the bird.
